OPTIONAL DETERMINATION OF NON-SIGNIFICANCE (DNS) NOTICE MATERIALS

Project Name/Address: Hazelwood Preliminary Plat/6018 Lk WA Blvd SE

WITTMAN DEVELOPMENT CRITICAL AREAS STUDY

APPENDIX D – WITTMAN DEVELOPMENT CRITICAL AREAS STUDY SITE PHOTOS

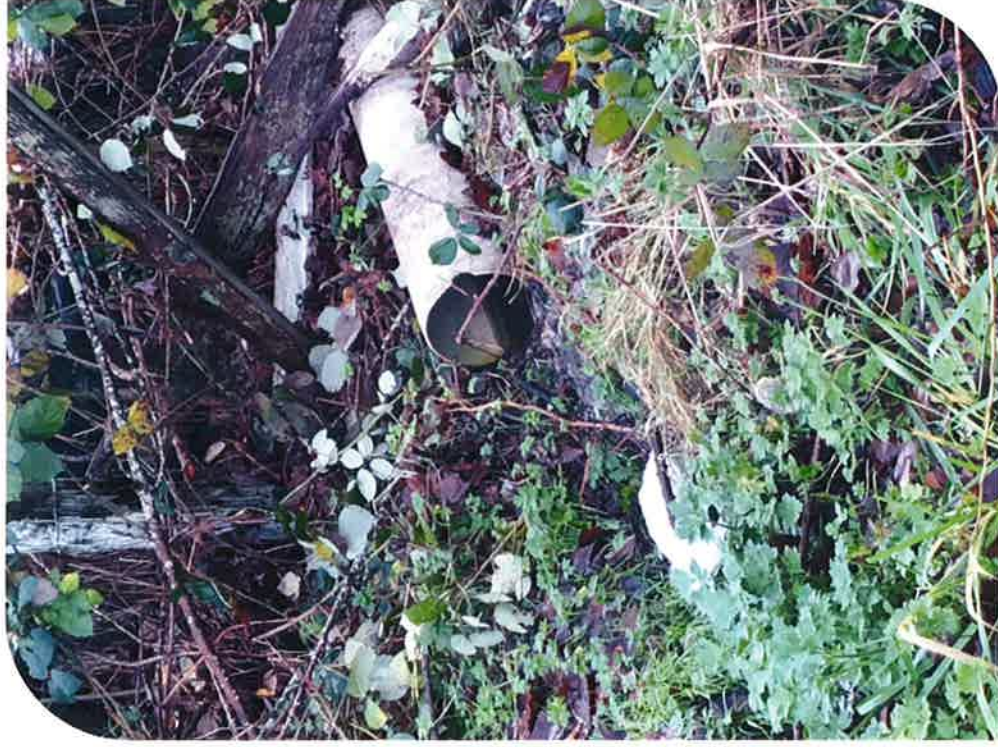
Photo 1 —Stormwater pipe from property to the south which has created the stormwater channel on site.

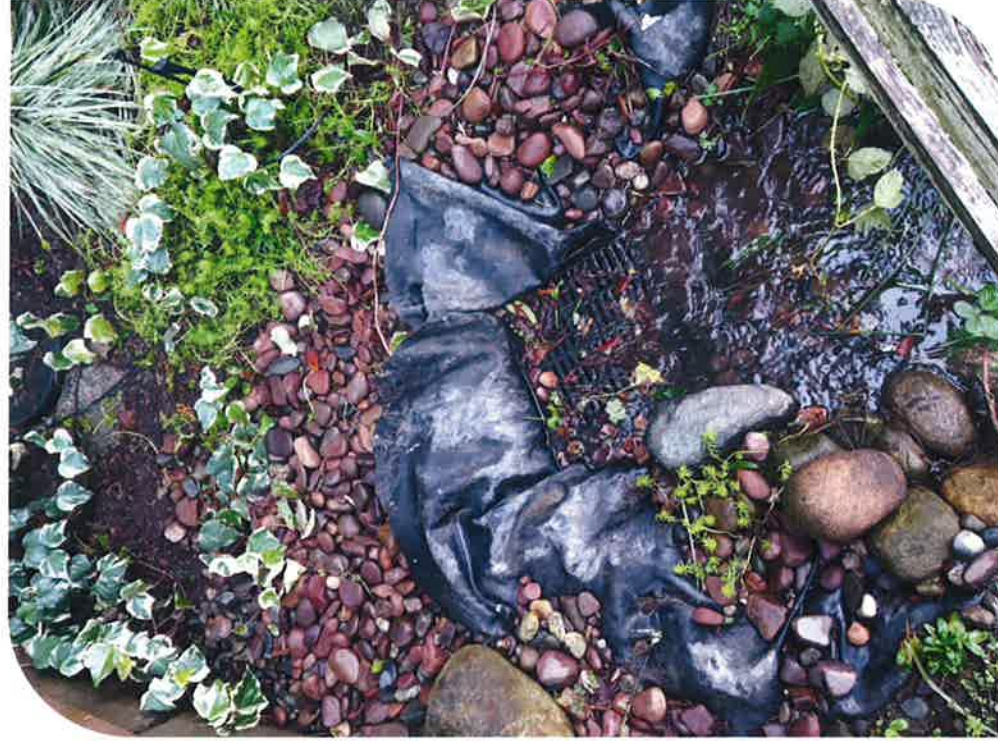
Photo 2 —Catch basin on property to the north which drains the stormwater channel.

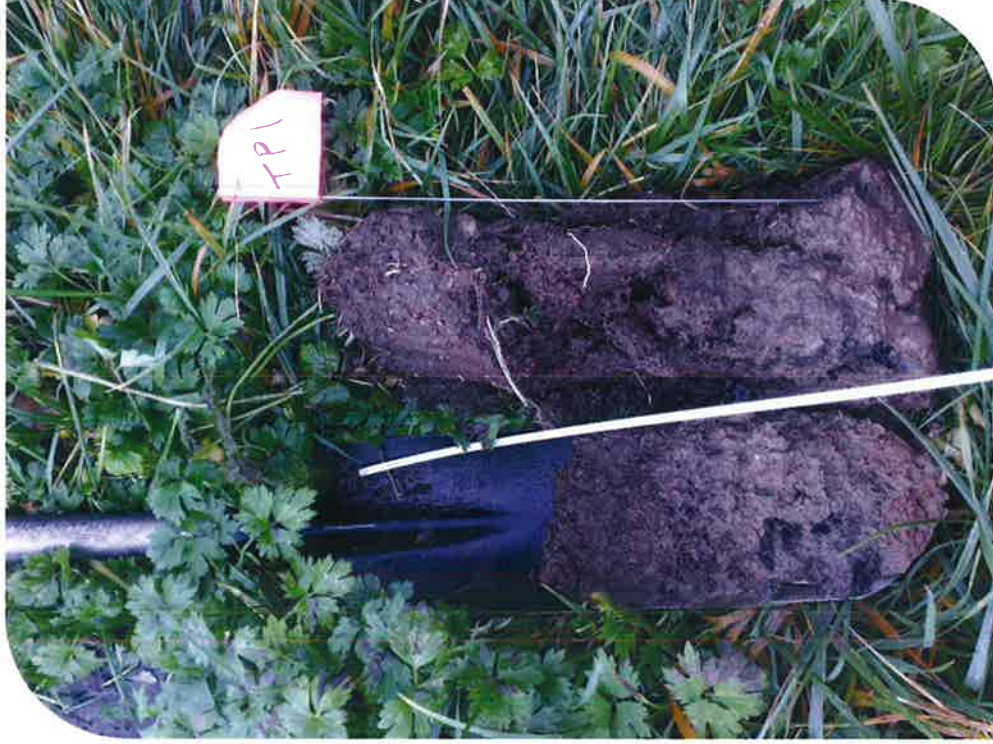
Photo 3 —TP-1 soil profile.

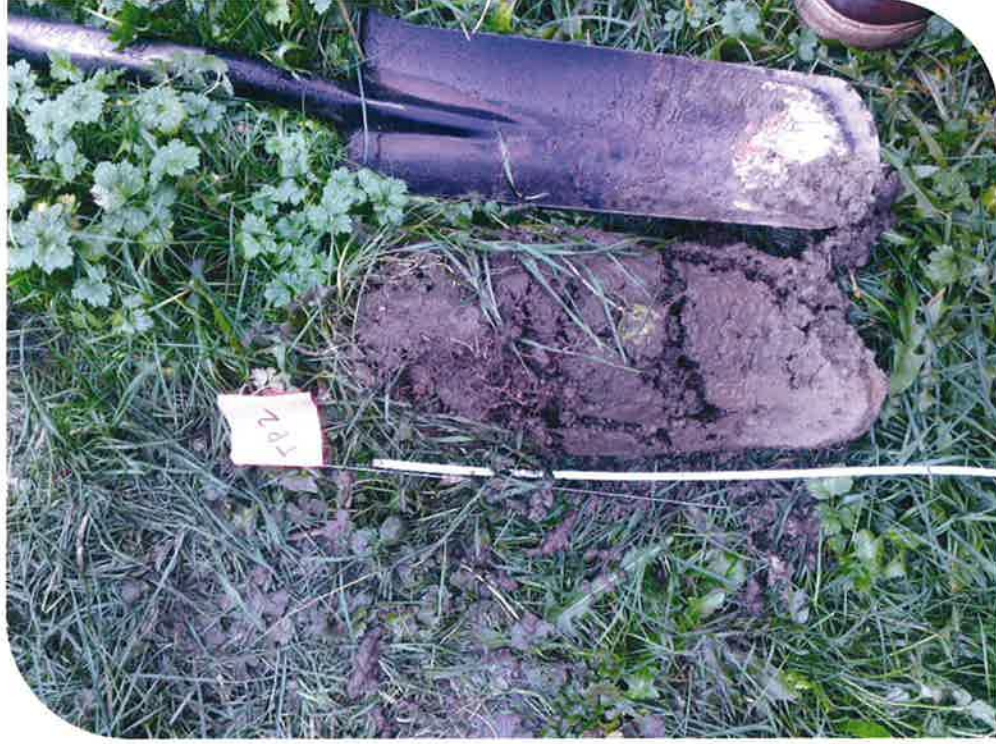
Photo 5 —TP-2 soil profile.

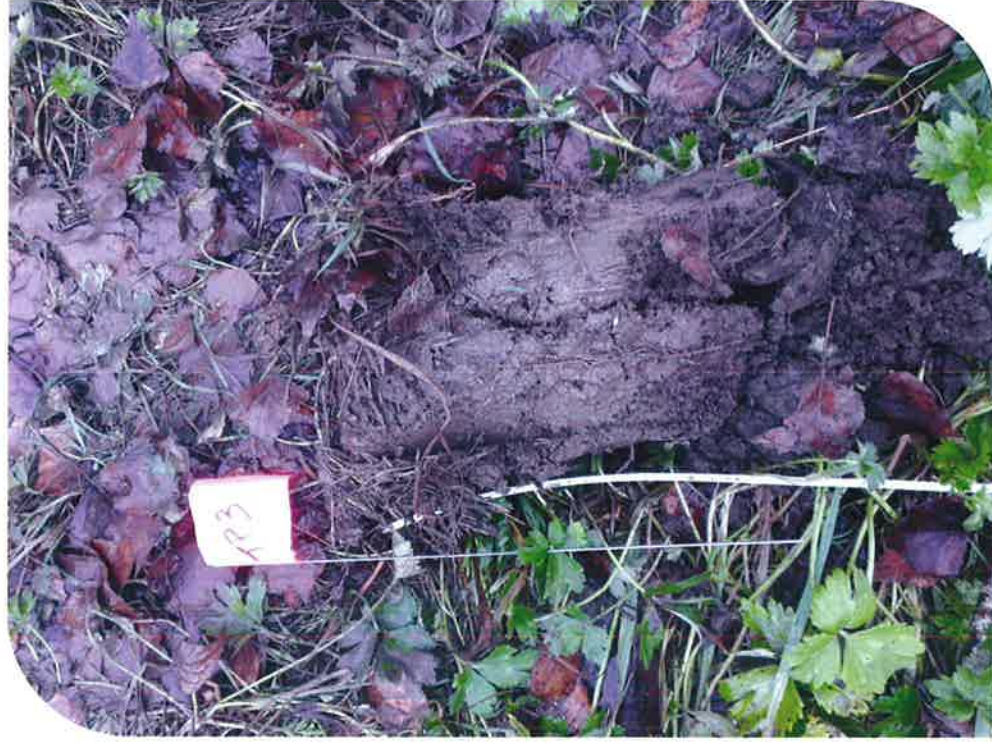
Photo 7 — TP-3 soil profile.

Depth (Inches)	Matrix		Redox Features				Texture	Remarks
	Color (moist)	%	Color (moist)	%	Type ¹	Loc ²		
0-11	10YR 3/2	100					loam	
11-15	10YR 3/1	70	2.5YR 2.5/4.5	50	C	PL/M	loam	gravelly

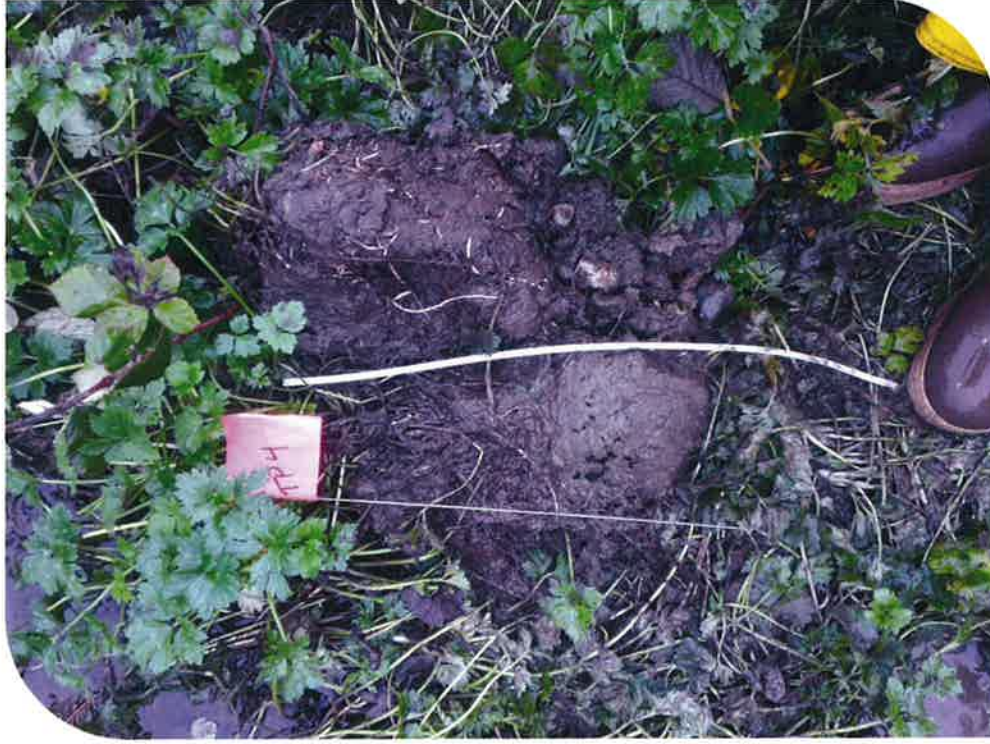
Photo 9 —TP-4 soil profile.

Confluence observed and delineated one area with wetland characteristics ("Area A"), and dug a total of 9 test pits (TPs) within the project area (Figure 5). Area A was characterized by test pits TP-4 and TP-6 (Appendix D, Photos 9-10, 13-14).

Depth (inches)	Matrix		Redox Features				Texture	Remarks
	Color (moist)	%	Color (moist)	%	Type ¹	Loc ²		
0-8	10YR 4/2	100					loam	
8-10								
10-15	10YR 4/2	60	10YR 3/6	10	C	PL	CLAY L (no soil)

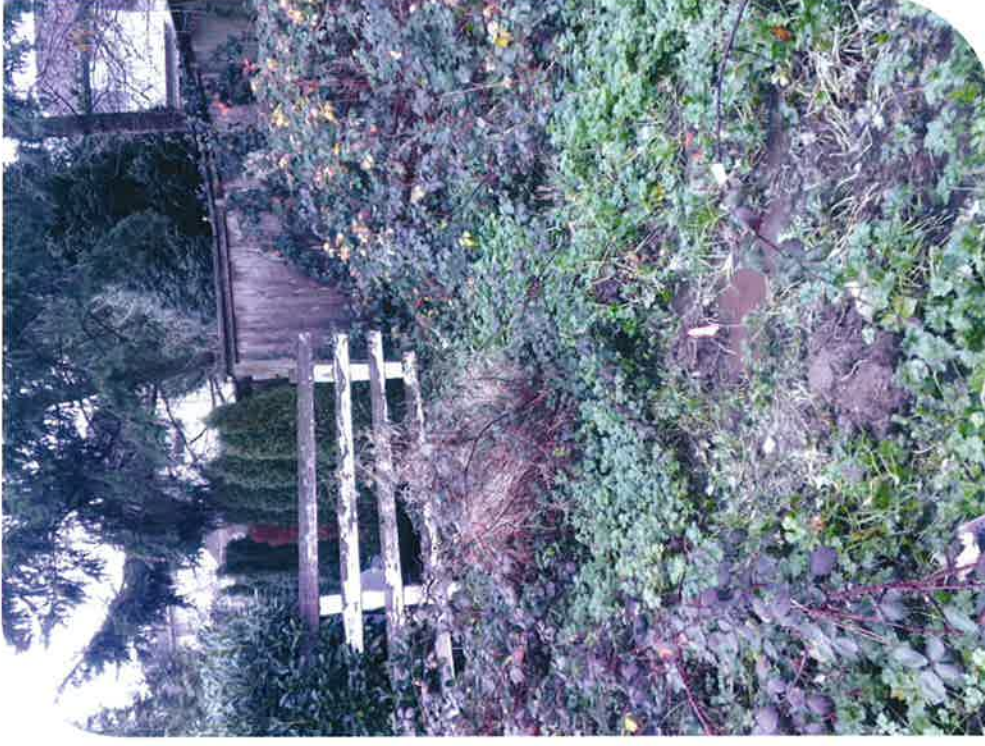
Photo 10 —TP-4, view to north.

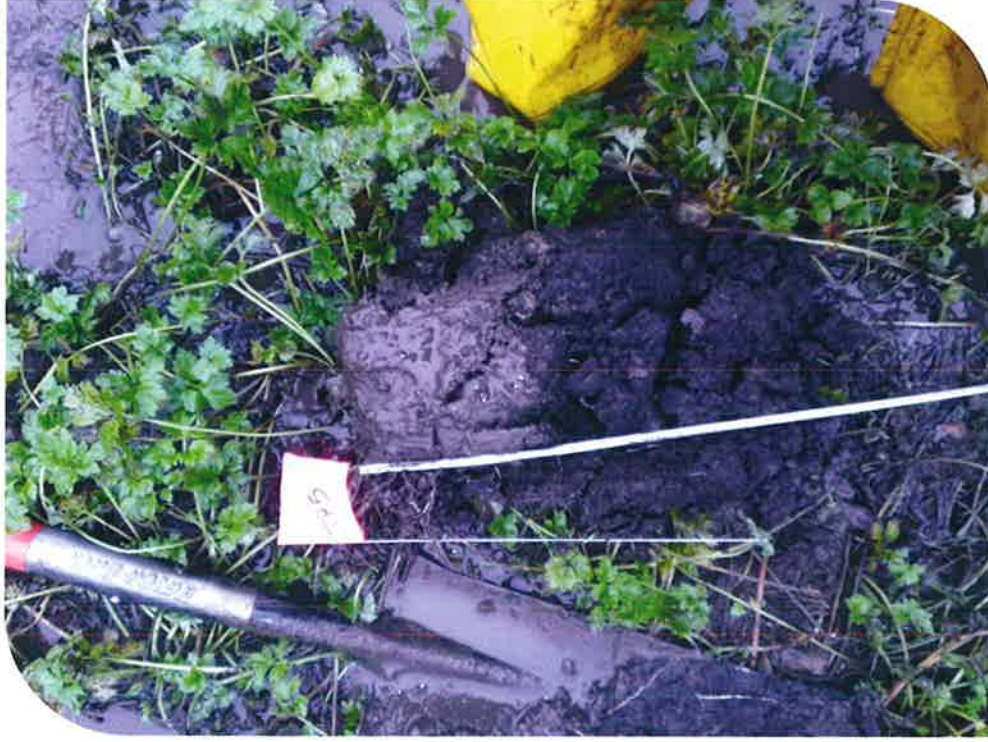
Photo 11 —TP-5 soil profile.

Depth (inches)	Matrix		Redox Features				Texture	Remarks
	Color (moist)	%	Color (moist)	%	Type ¹	Loc ²		
0-5	10YR 5/2	100						
5-11	10YR 5/2	85	5YR 2/4	15	C	M		
11-15	10YR 5/1	70	5YR 2/4	30	C	M

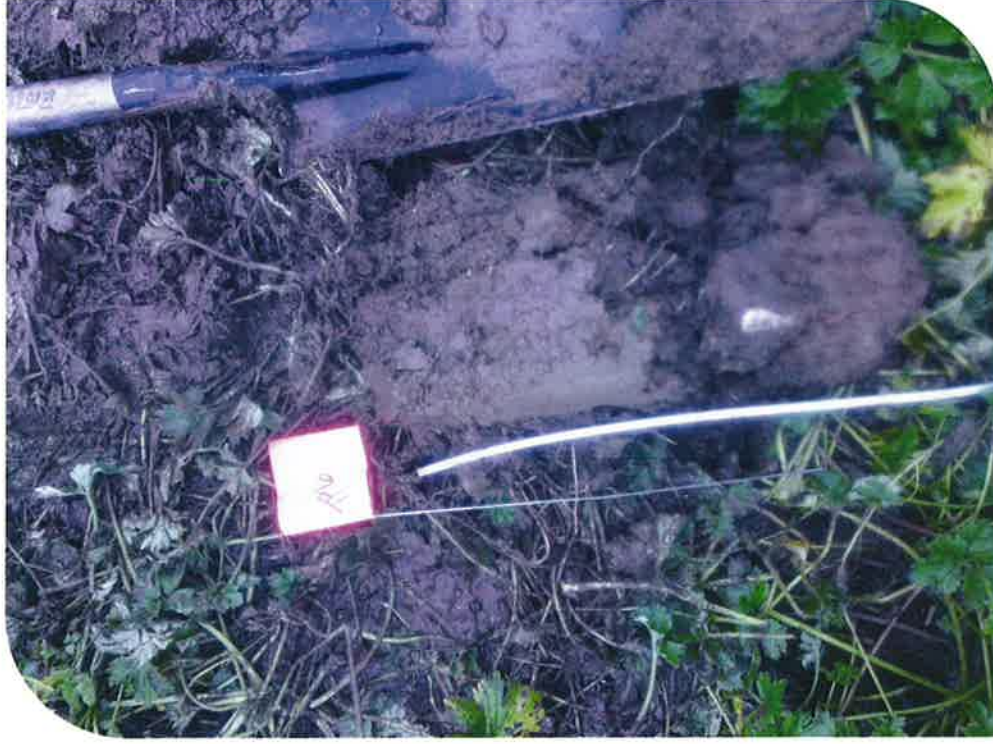
Photo 13 — TP-6 soil profile.

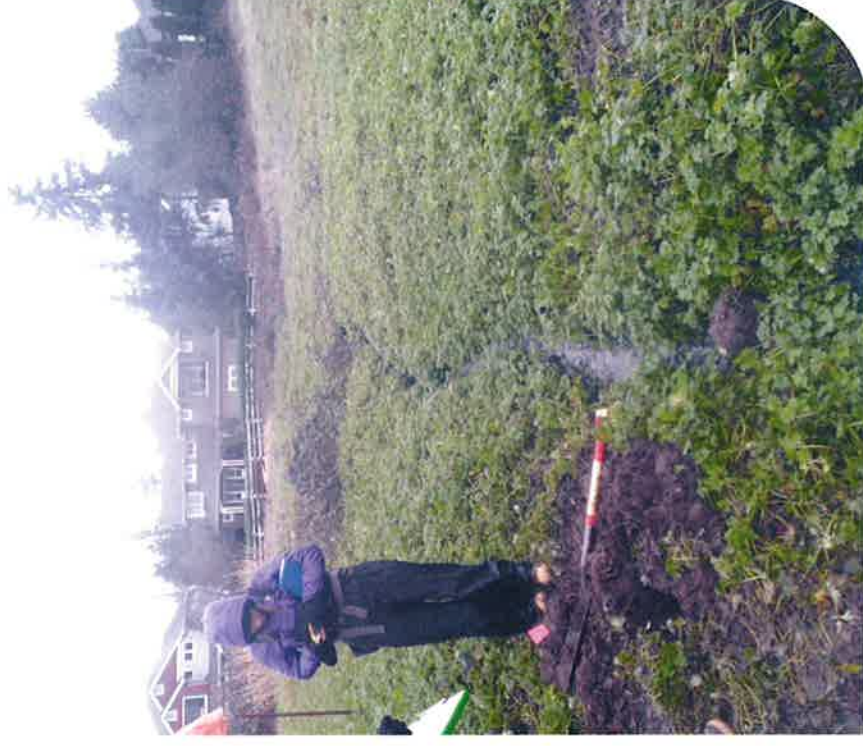
Photo 14 — TP-6, view to north. Note adjacent stormwater channel.

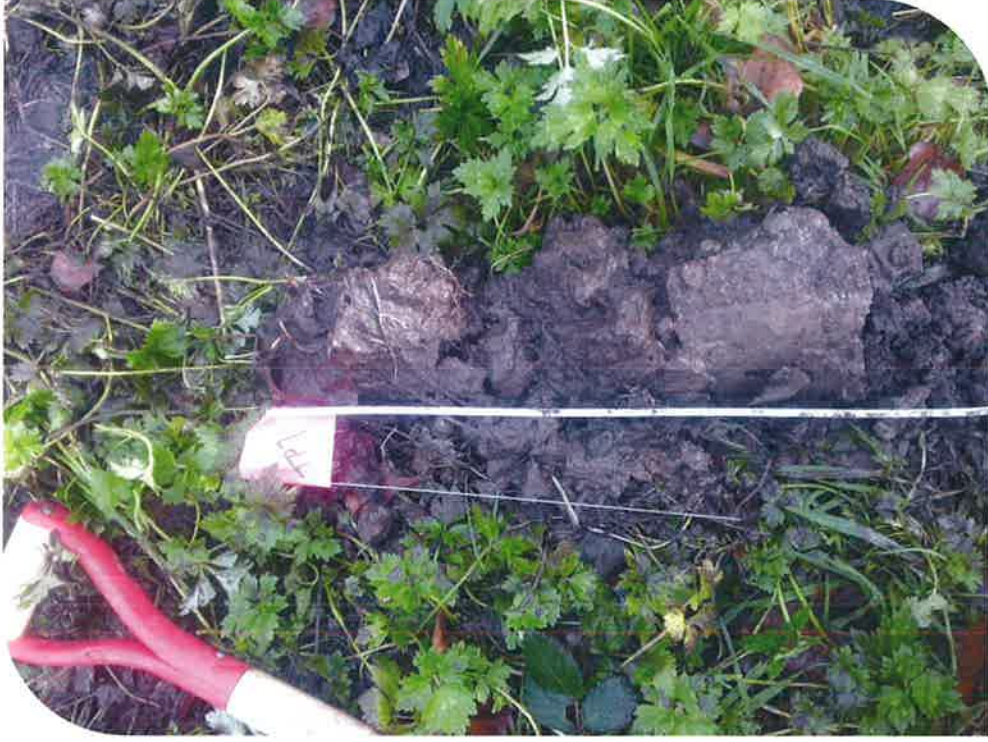
Photo 15—TP-7 soil profile.

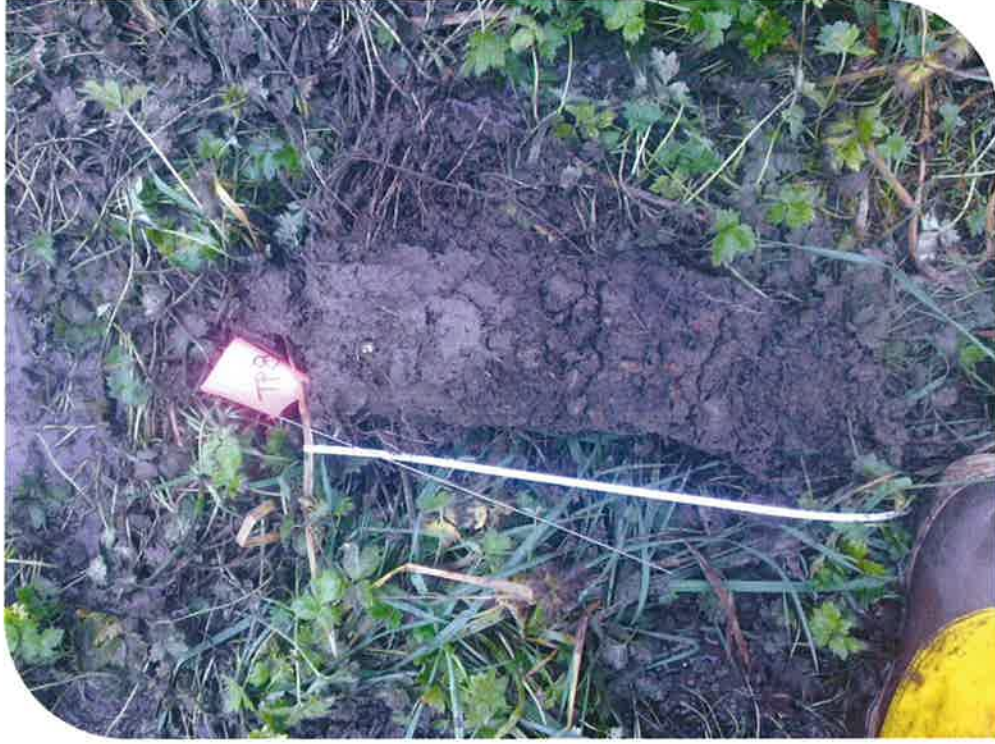
Photo 16 — TP-8 soil profile.

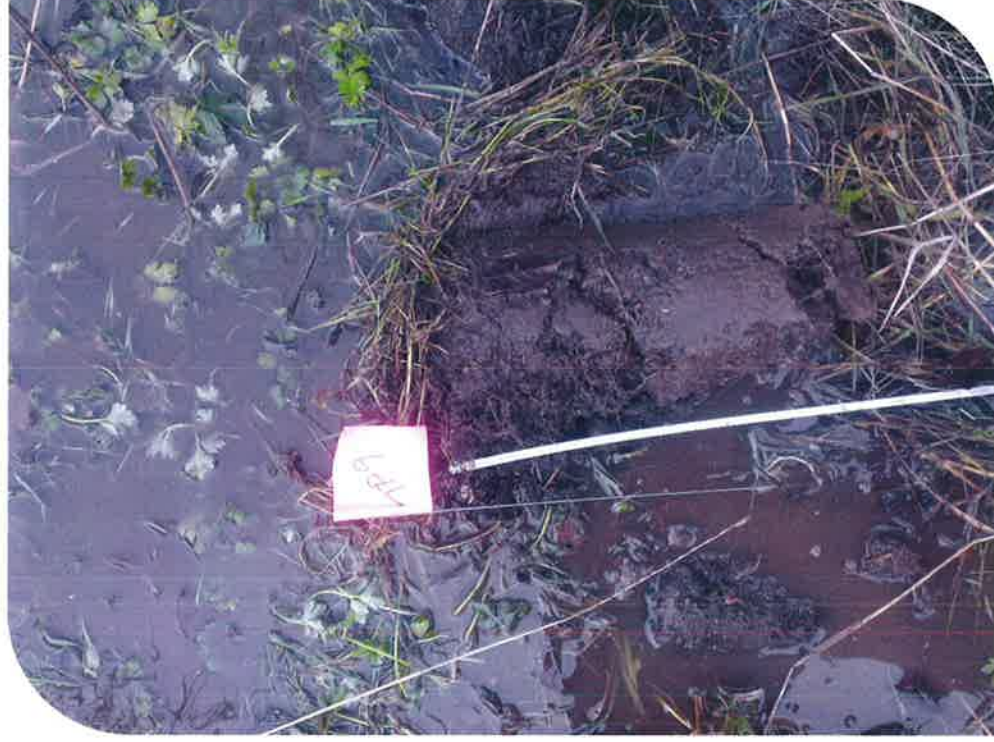
Photo 18—TP-9 soil profile.

Depth (inches)	Matrix		Redox Features				Texture	Remarks
	Color (moist)	%	Color (moist)	%	Type ¹	Loc ²		
0-7	10YR 3/2	100					loam	
7-17	10YR 4/3	99	10YR 7/2	1	C	M	sandy loam

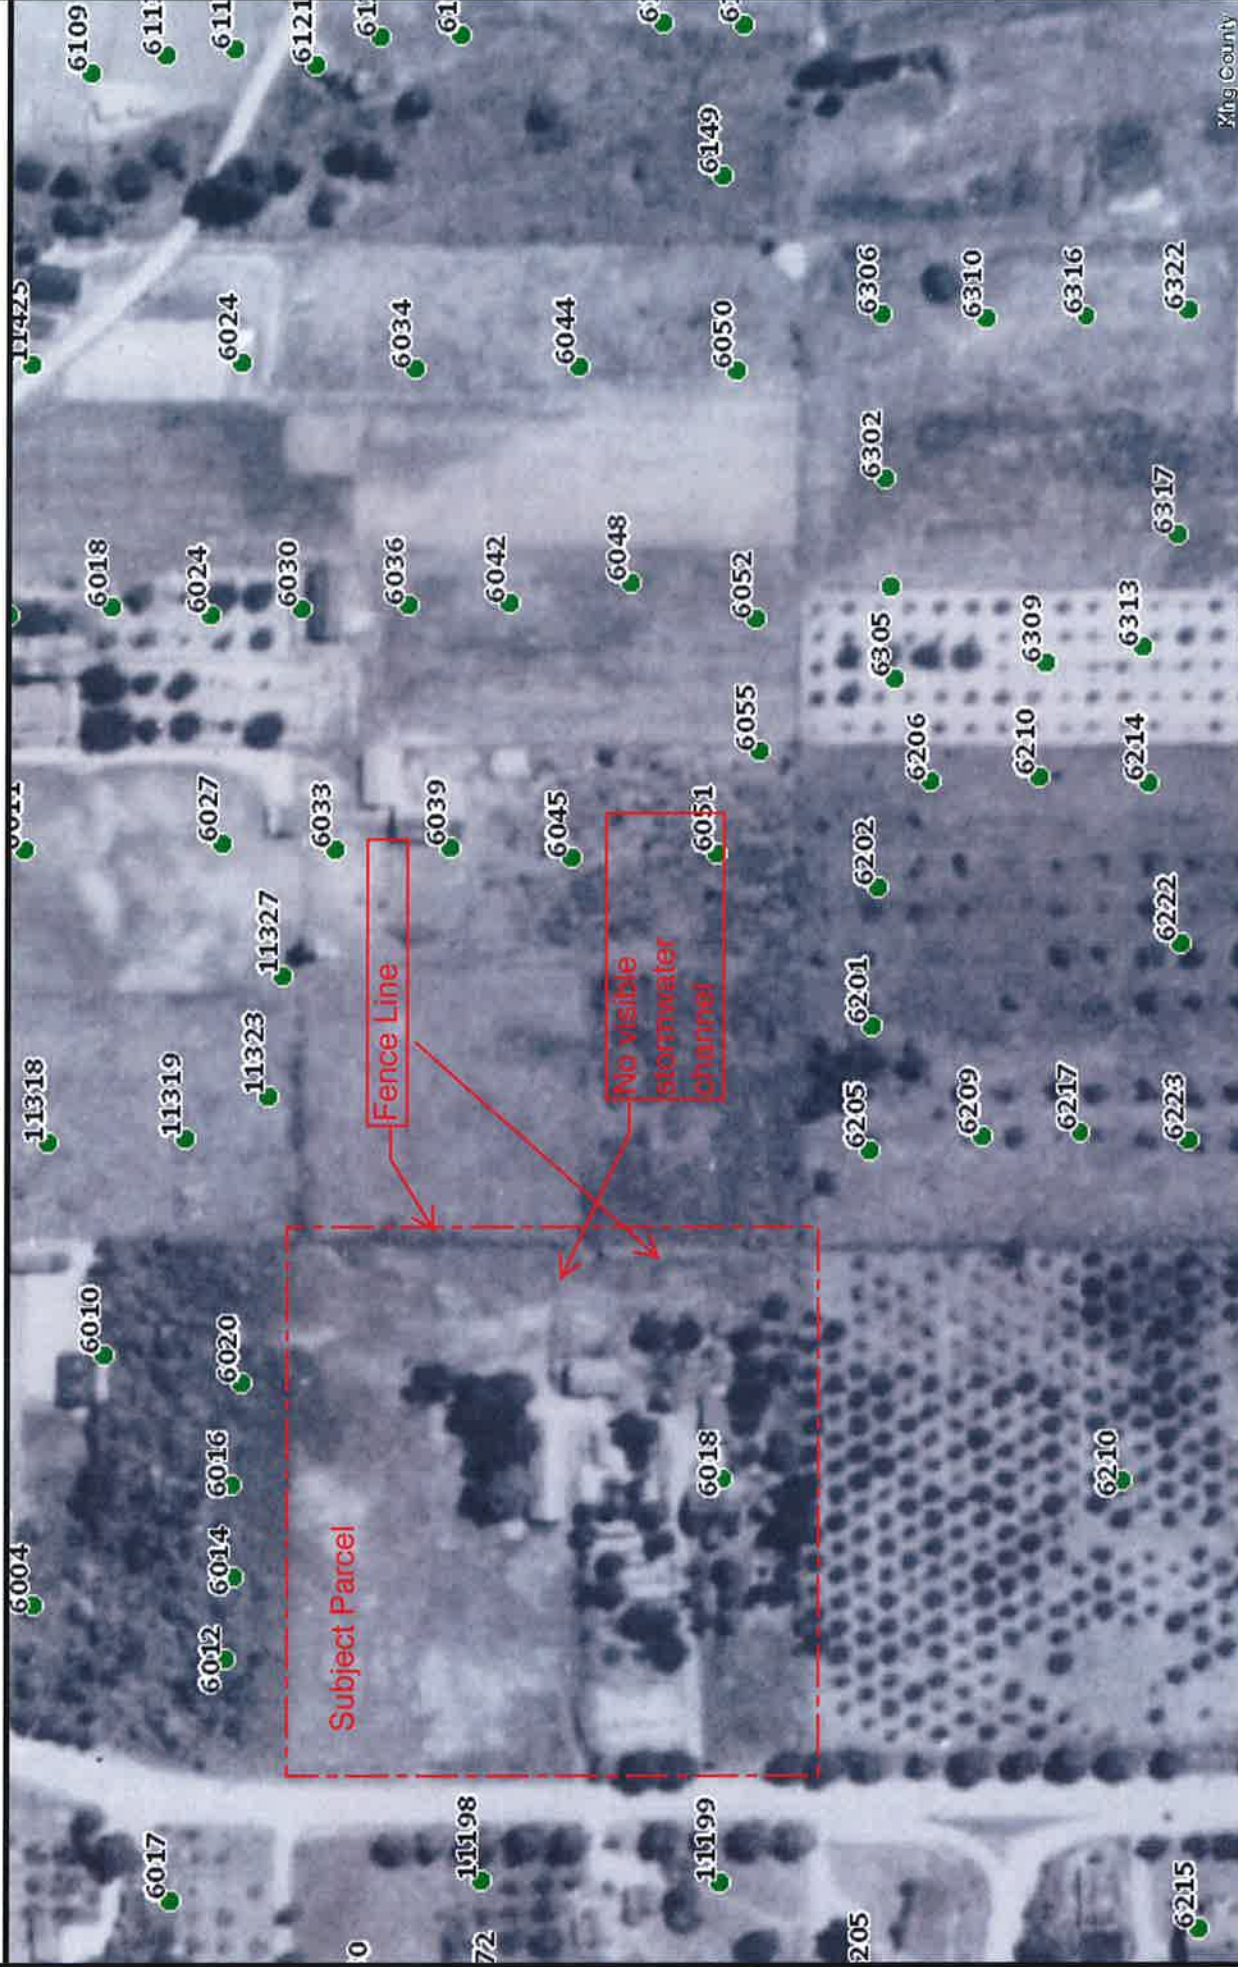
King County iMap 1936 Air Photo

No visible
stormwater
channel

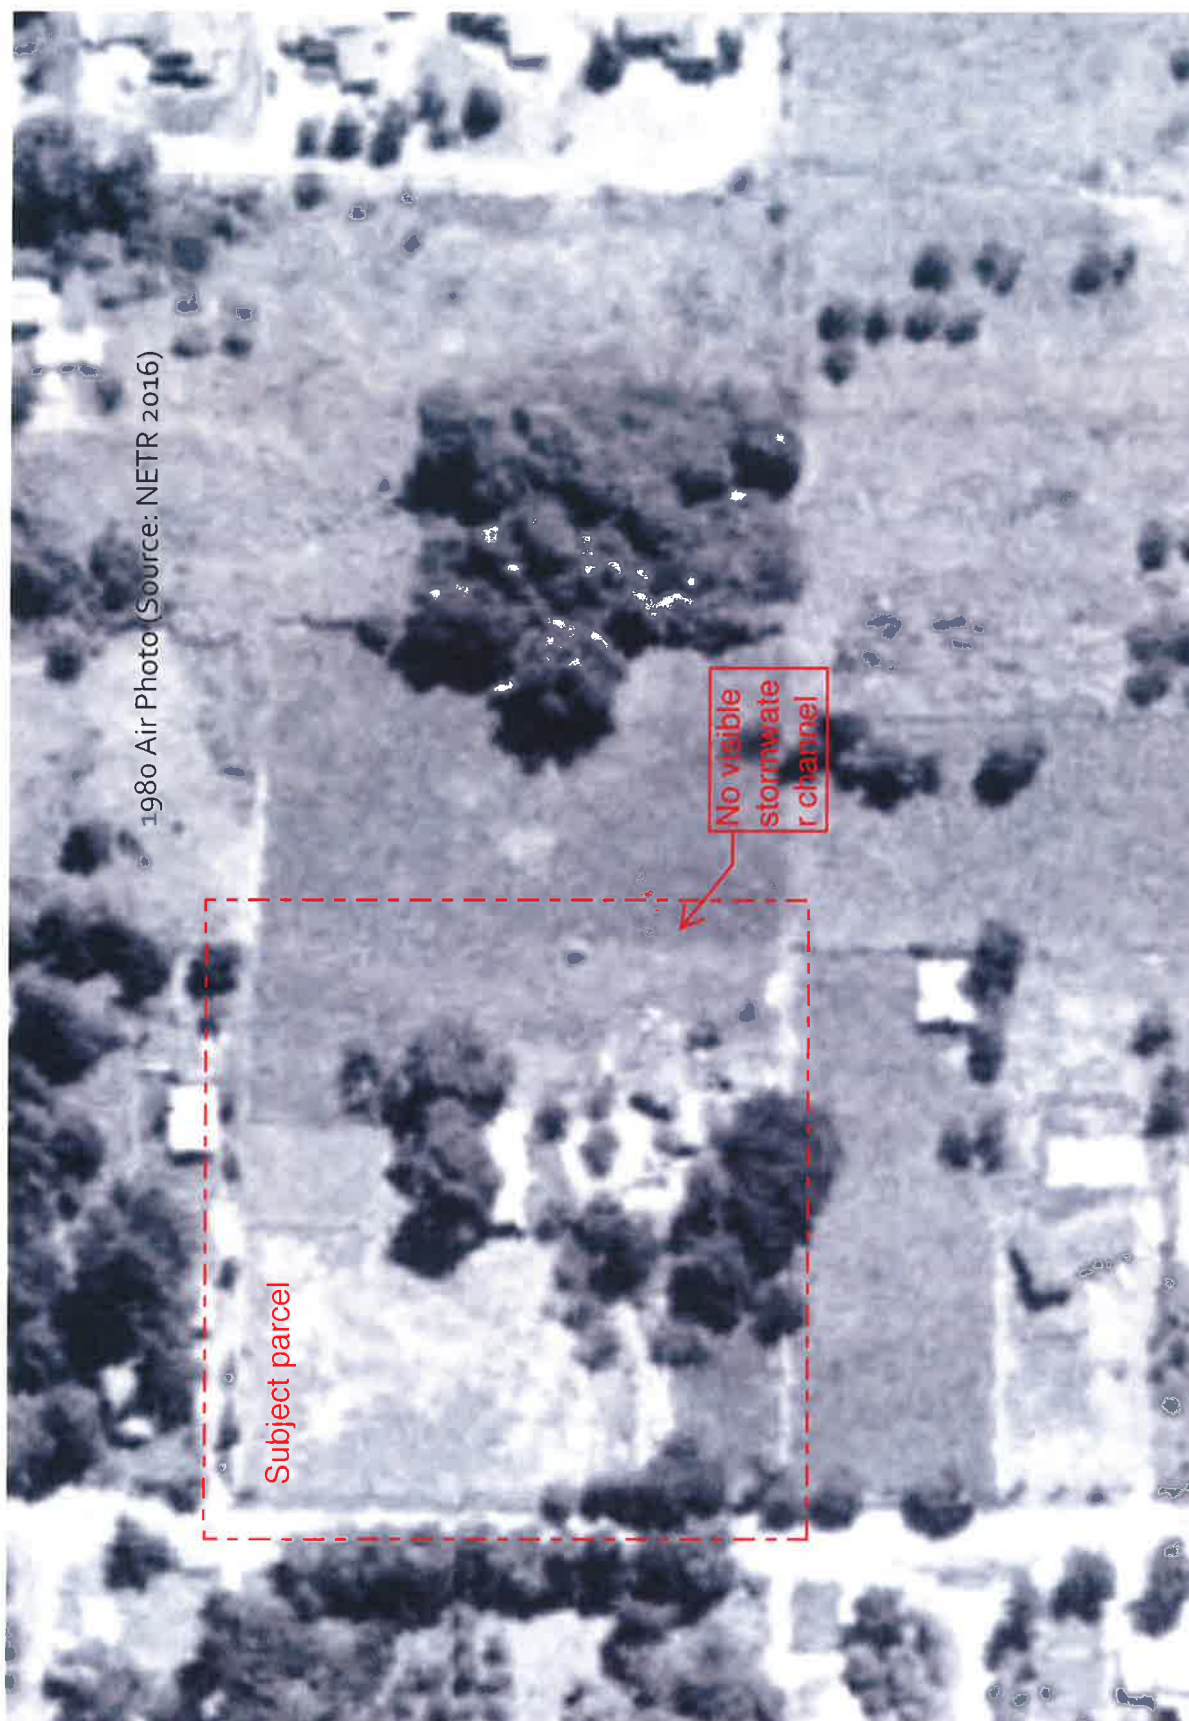
1980 Air Photo (Source: NETR 2016)

No visible
stormwater
r channel
